# **Geology and Preliminary Hydrogeologic Characterization of the Cell-House Site, Berlin, New Hampshire, 2003-04**

Scientific Investigations Report 2004-5282

**U.S. Department of the Interior  
U.S. Geological Survey**

By James R. Degnan, Stewart F. Clark, Jr., Philip T. Harte, and Thomas J. Mack

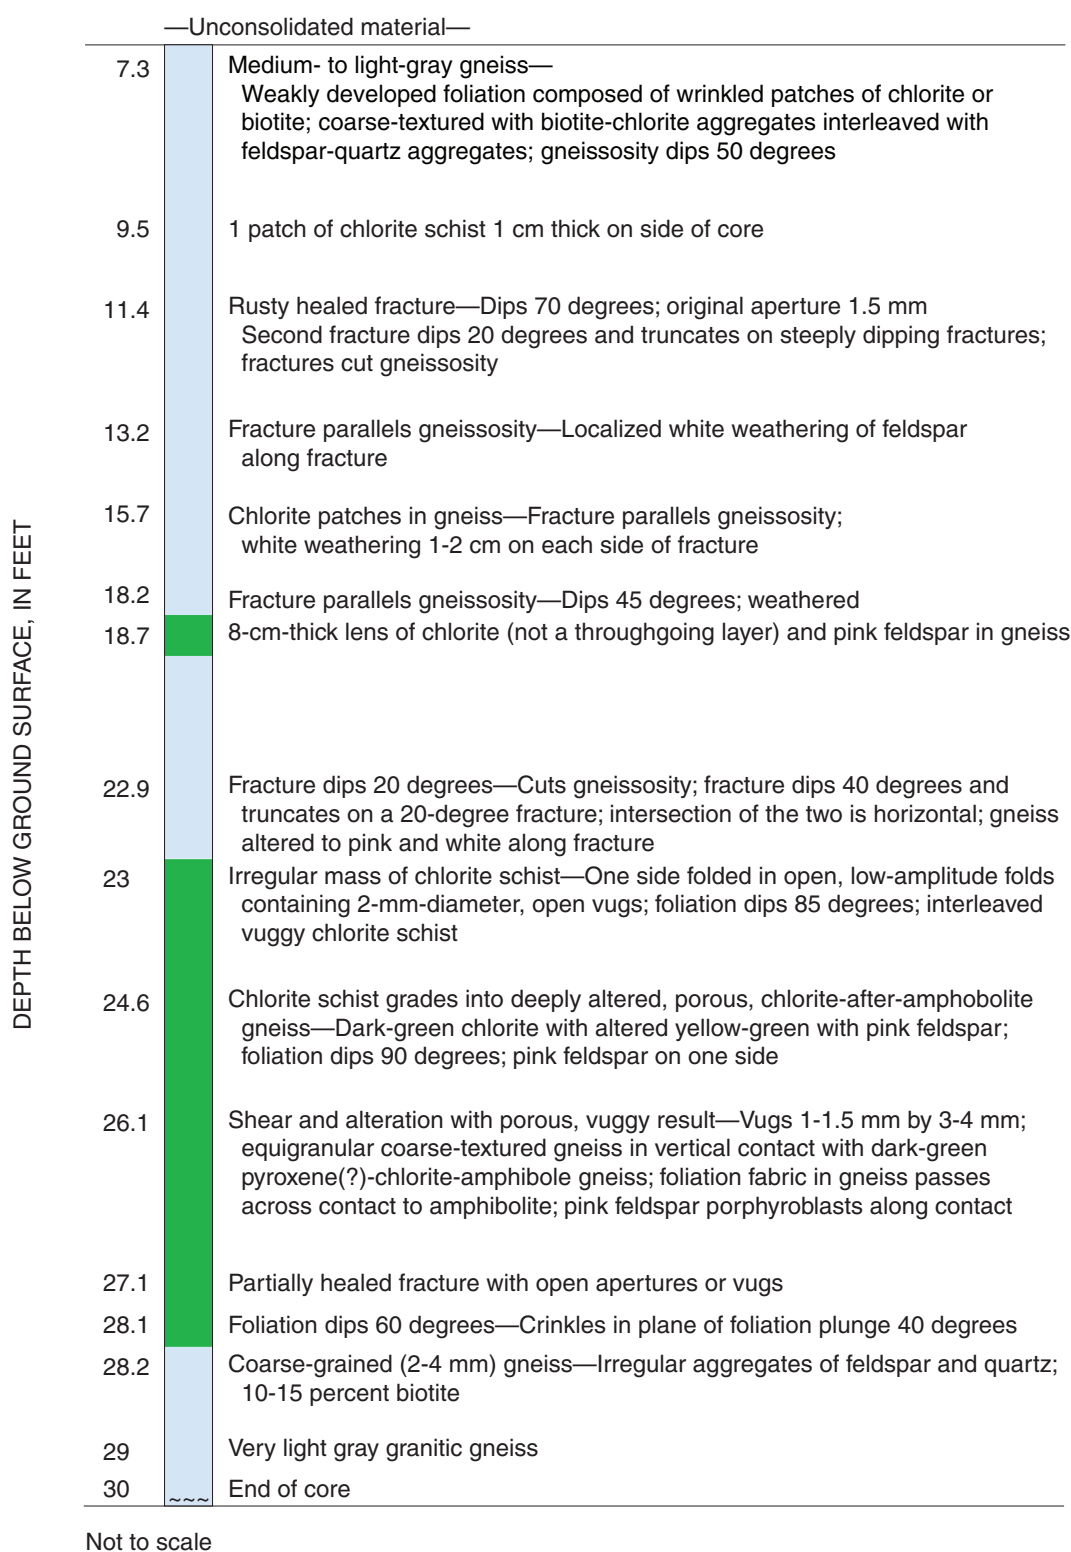
**Figure 1-6.** Core log from borehole at bedrock well MW-10A, cell-house site, Berlin, N.H. (See figure 2 for location of well and plate 1 for structure and distribution of rock types.)
